Surf Coast Shire

Painkalac Creek and Estuary

Pollution Source Investigation

Final Report

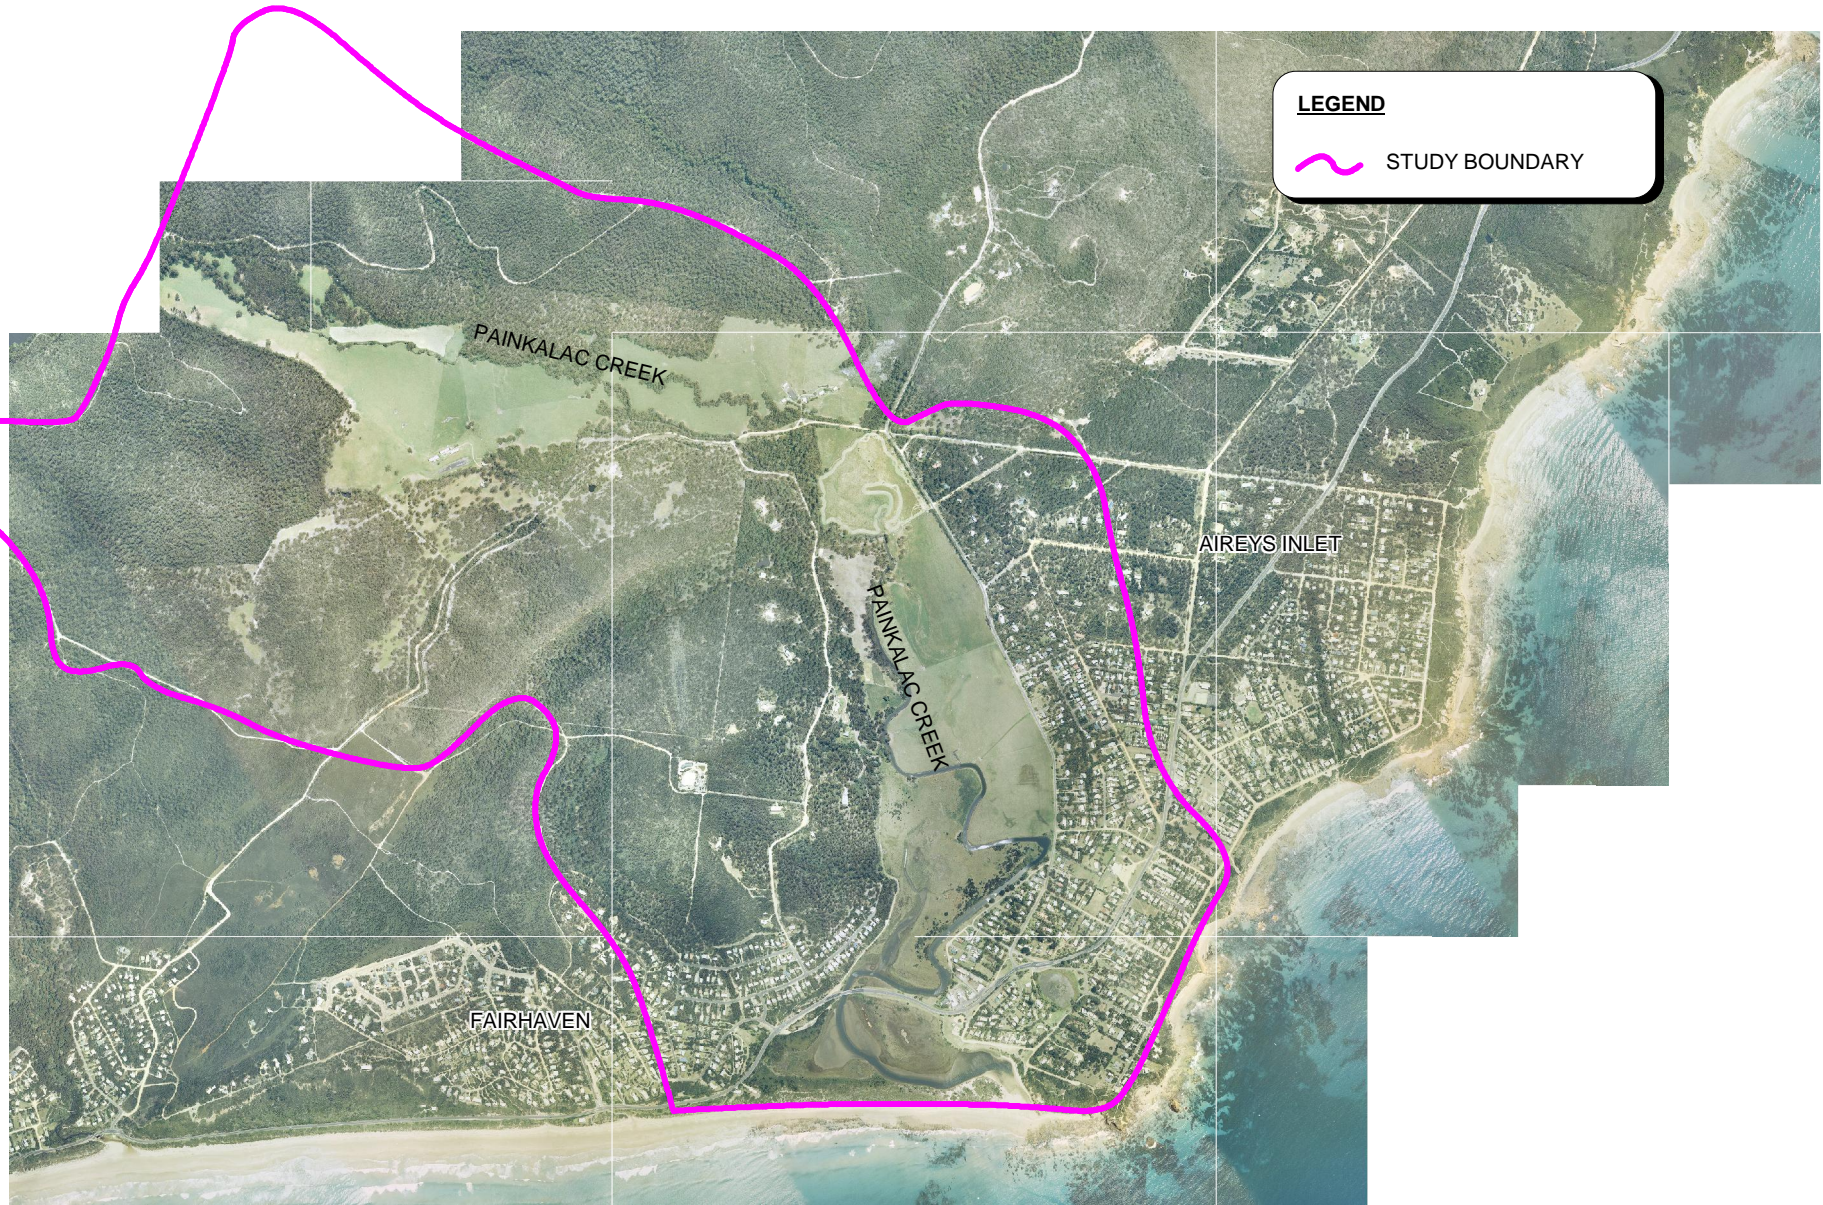
Project: Lower Painkalac Creek Pollutant Source Investigation				
Title: FIGURE 1: STUDY AREA				
Project No:	31/16616	Date:	14/06/2005	A4
Scale: 1:25000			Sh 1 of 1	Rev. 0

The primary area of interest for this investigation was the lower reach of the Painkalac Creek, between the boundary of the Angahook-Lorne State Park and the coast, as shown in Figure 1. The lower catchment area that lies to the north of the Great Ocean Road consists of open pasture on private land and a 16.3 ha parcel of land owned by the Surf Coast Shire which has a Trust for Nature Conservation Covenant. The area to the south of the Great Ocean Road is a combination of Council owned and managed land and Crown land managed by a committee of management (Great Ocean Road Coast Committee).

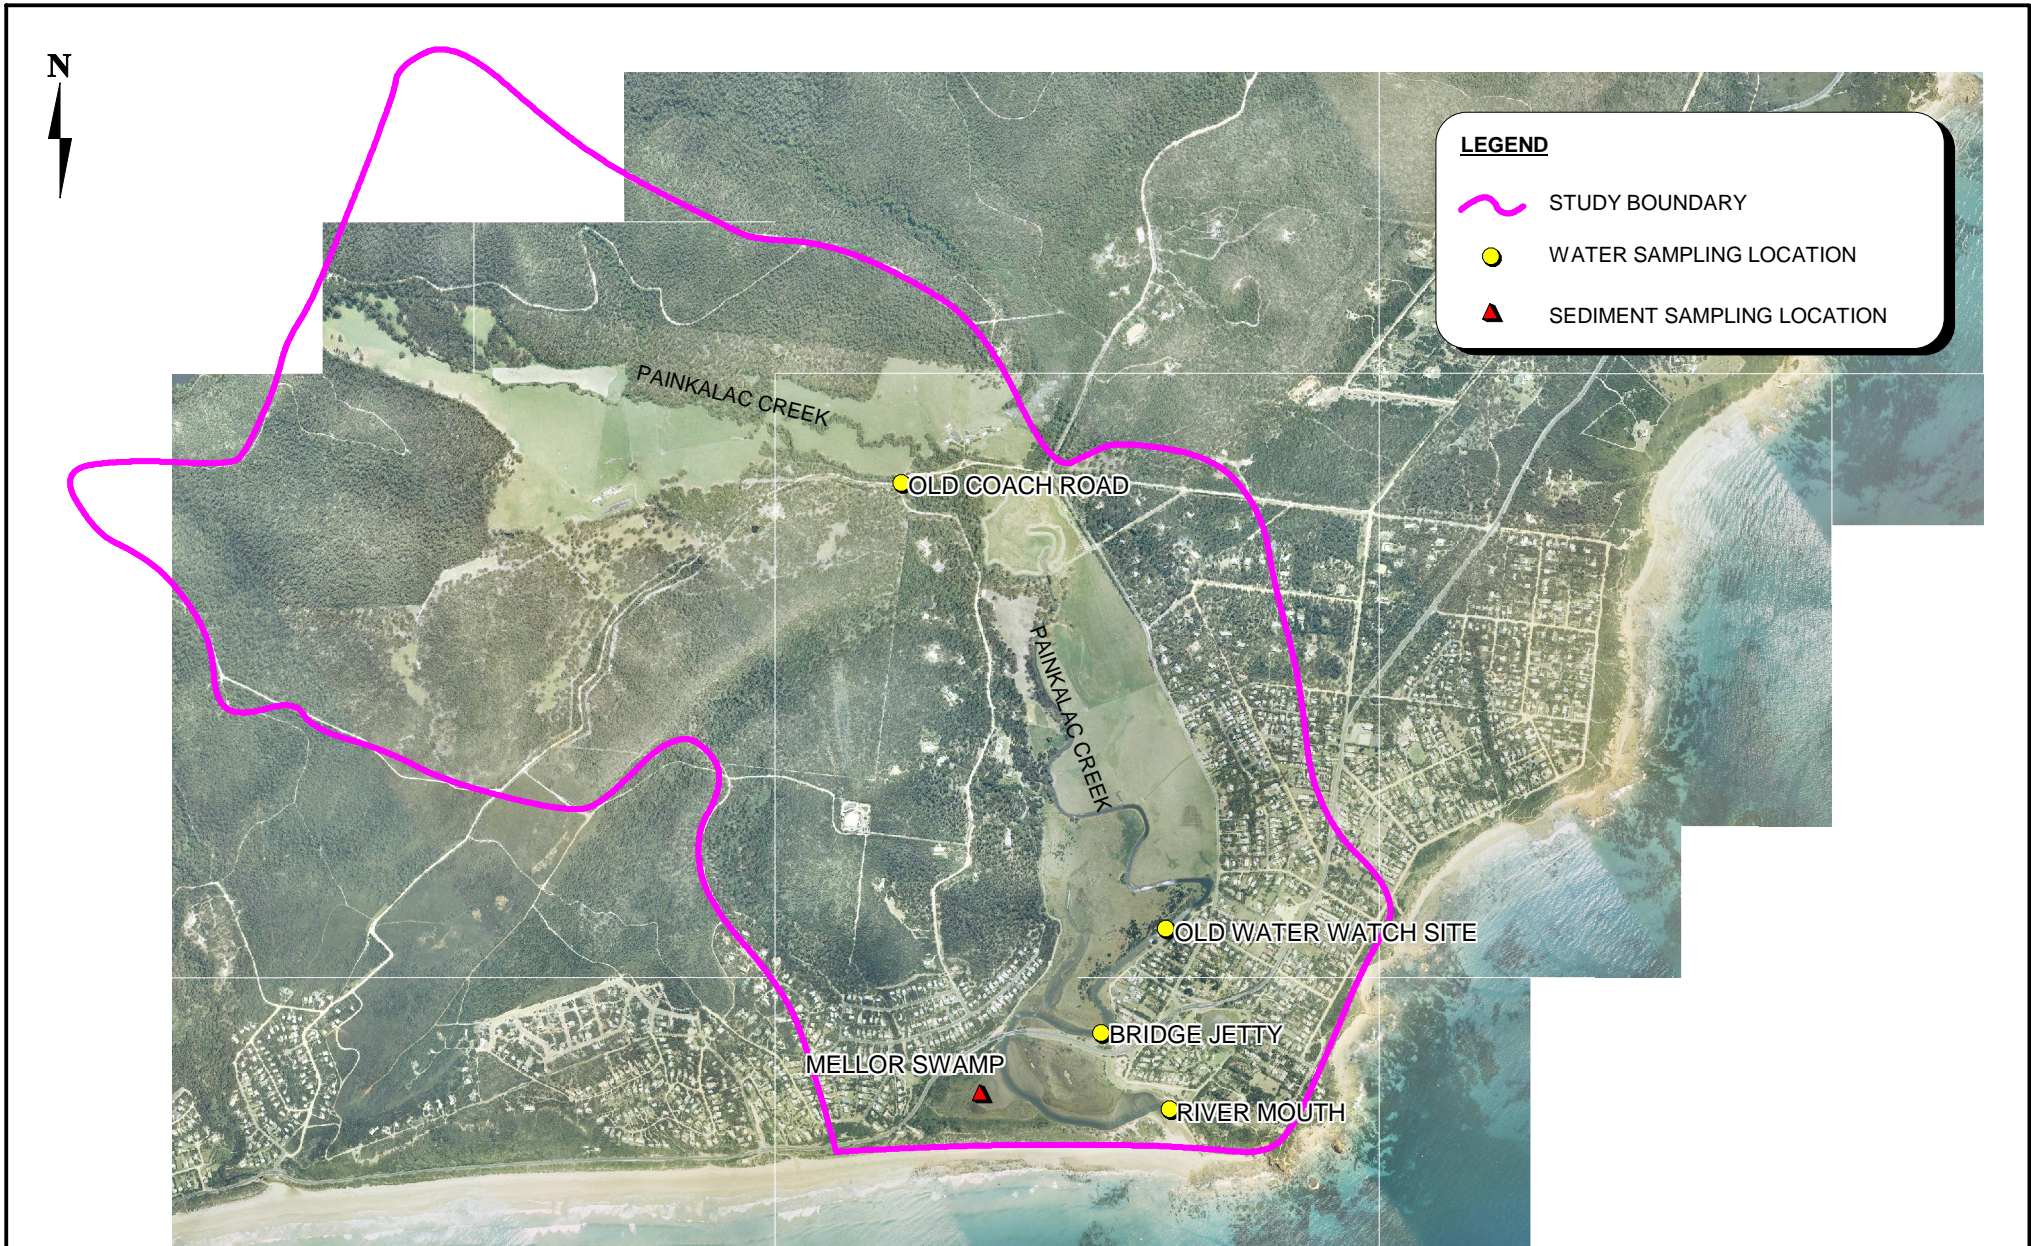
Sampling sites were chosen to allow comparison to previous studies that have been conducted, and to allow the detection of changes in different stretches of the river that reflect different land uses or discharges. Sample sites are shown in Figure 2. Sampling was conducted on four different occasions, to ensure adequate replication, although it should be noted that the results represent a 'snapshot' in time, and do not give adequate indication of the long-term conditions. Ideally, sampling of baseline conditions should be conducted regularly over a period of several years, to allow for seasonal variation, and even longer to allow for longer-term variation in rainfall and other climatic conditions. No rainfall events were recorded for the duration of the current study, therefore, this is considered to be a dry season study, and does not assess the impact of rainfall, high flow or stormwater run-off.

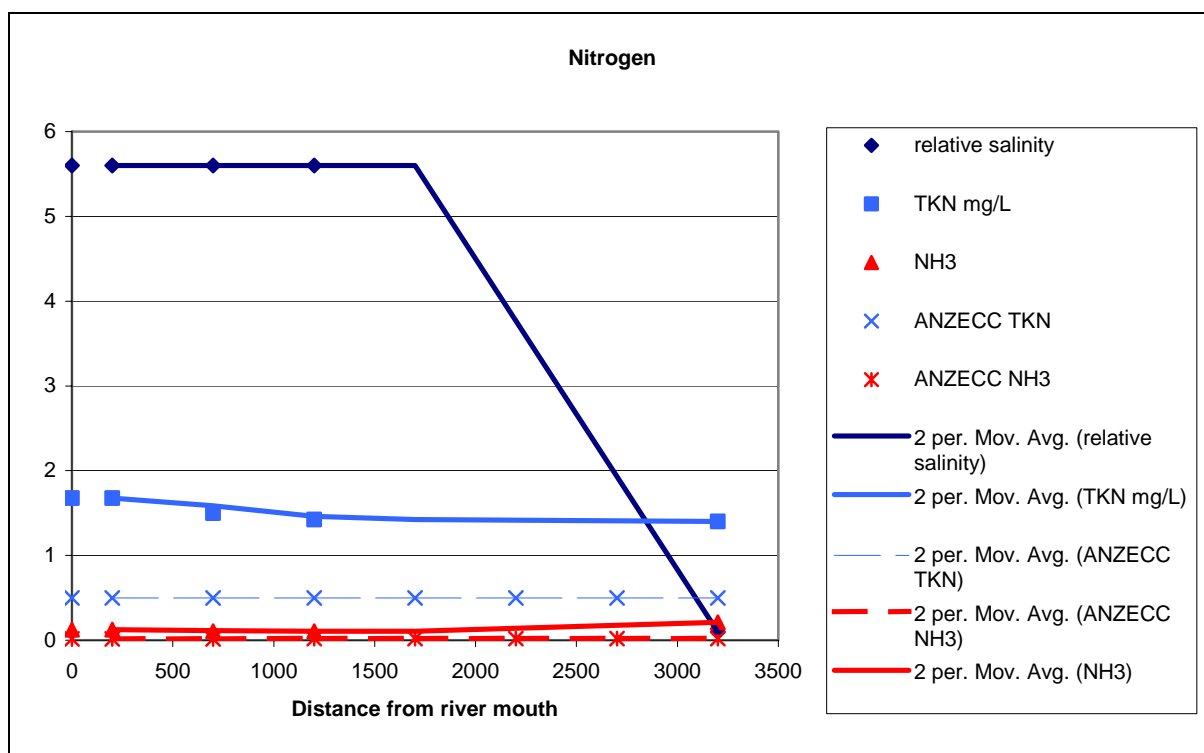
Figure 3 Nitrogen levels in Painkalac Creek.

(TKN = Total Kjeldahl Nitrogen (TKN = NH₃ + Organic-N), NH₃ = Ammonia. Mov. Avg. = moving average)

Figure 3 shows that while total nitrogen levels are elevated relative to ANZECC guidelines and to historical data (not shown here), the proportion of this which is in a toxic form (NH₃) is relatively low. Ammonia can come from fertiliser inputs, livestock waste and septic tanks, and is also a product of natural bacterial decomposition. Total oxides of nitrogen comprised a very small proportion of total nitrogen. This indicates that most of the nitrogen in the creek is in organic form, however this nitrogen can be broken down by bacteria into ammonia, a process that is dependent upon conditions in the creek such as temperature. The toxicity of ammonia is also dependent upon pH and temperature.

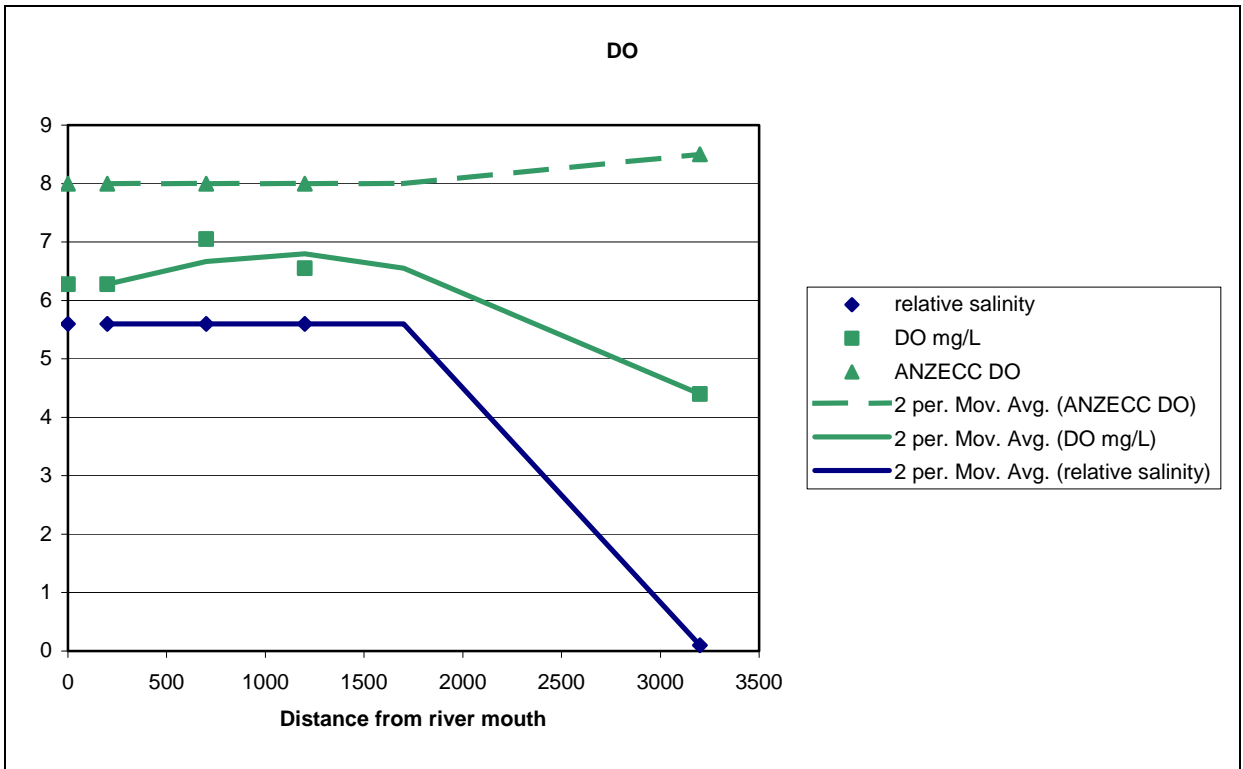
Figure 4 Dissolved oxygen in Painkalac Creek

(DO = dissolved oxygen, mg/L = milligrams per litre, Mov. Avg. = moving average)

Figure 4 shows that average dissolved oxygen levels in the creek were below ANZECC recommended guidelines. They were also below historical averages (not shown). In addition, the guidelines expect higher dissolved oxygen levels in freshwater than marine waters, but the Painkalac Creek shows the opposite trend, i.e., DO was lower further upstream.

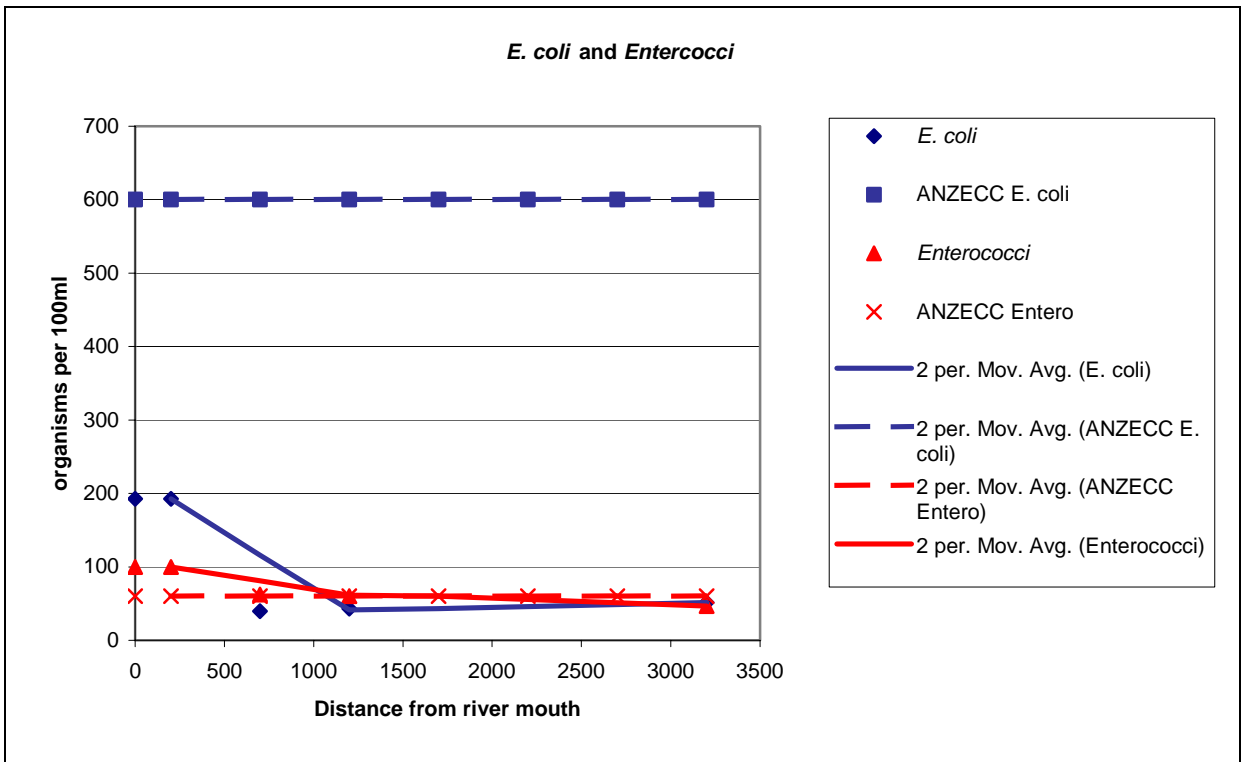
Figure 5 *E. coli* and Enterococci in Painkalac Creek

(Mov. Avg. = moving average)

Figure 5 shows that the levels obtained in each *E. coli* sample were below the ANZECC guidelines for primary contact for individual samples, but that *Enterococci* levels exceeded guidelines on a number of sampling events.

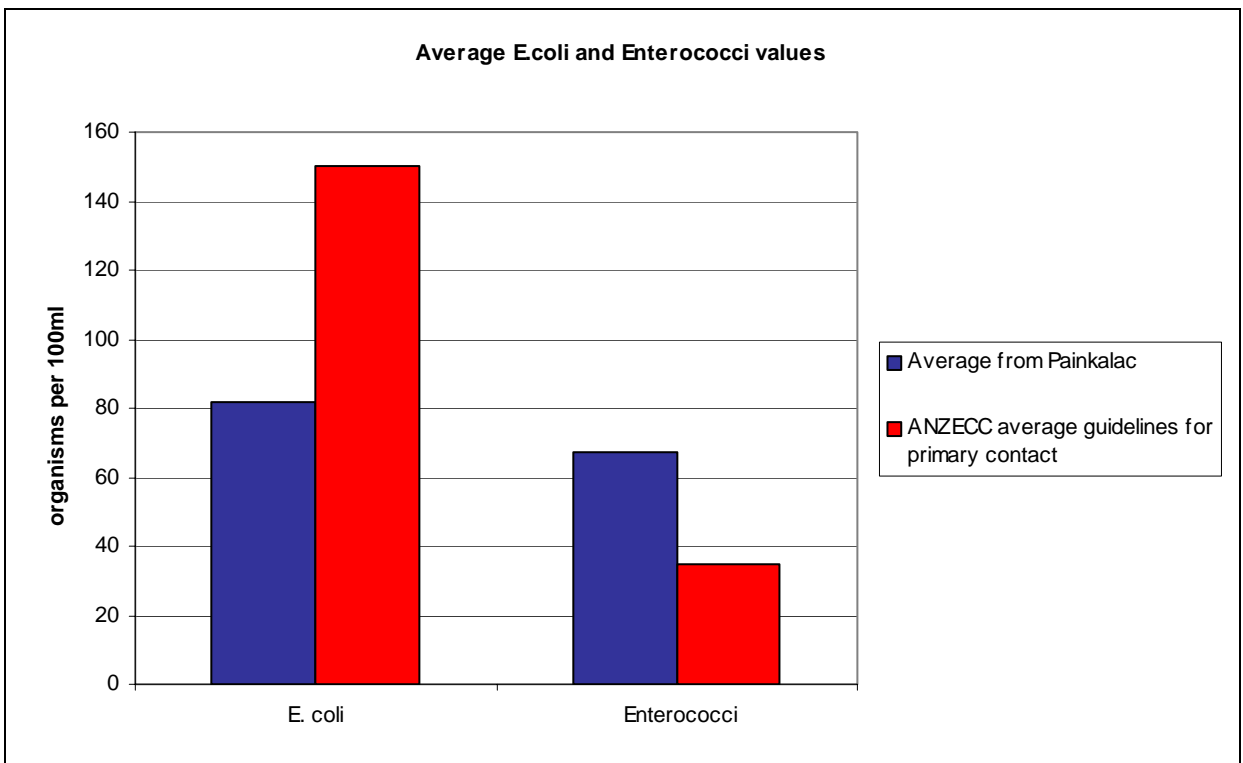
Figure 6 Average *E. coli* and *Enterococci* in Painkalac Creek

Figure 6 shows that average *E. coli* levels were within ANZECC guidelines for primary contact, but average *Enterococci* levels were higher than recommended for safe primary contact.
