# Field observations of geomorphic change during artificial estuary openings

**Report prepared for:**  
Corangamite Catchment Management Authority (CCMA)

v 2.0 Feb 2020

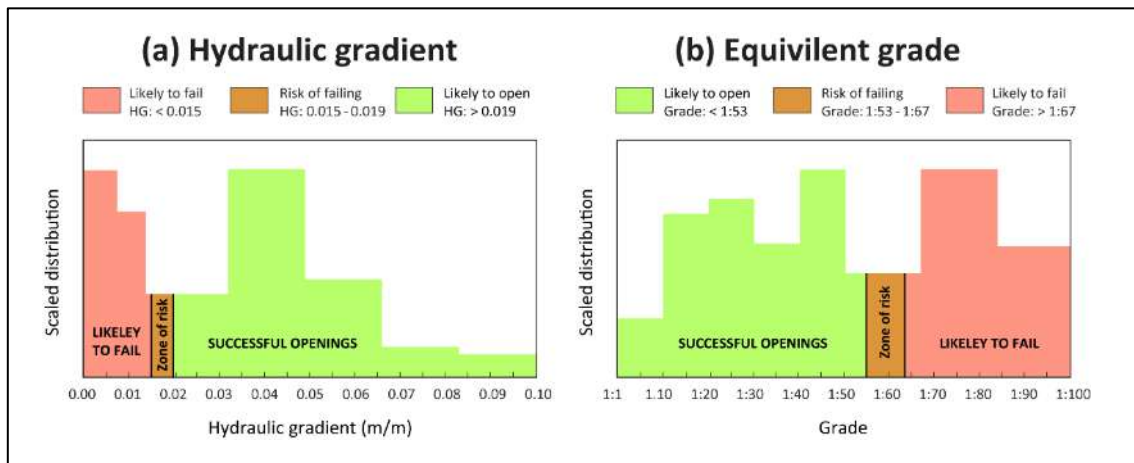
**Figure 1a-b.** (a) Hydraulic gradient; and (b) equivalent grade at which artificial openings are likely to be successful, unsuccessful, and at risk of failing - based on distributions from historic data (n = 63).

- (1) **The hydraulic gradient at the time of opening controls the success of an artificial opening.** Artificial openings have historically been successful when the hydraulic gradient is  $>0.019$  m/m (Figure 1a). This equates to a minimum grade of 1:53 (Figure 1b). Openings have been unsuccessful when the hydraulic gradient is  $<0.015$  m/m (grade of 1:67) and have had mixed success when 0.015-0.019 m/m (Figure 1a-b). This provides a threshold for successful opening and a zone of risk when openings could go either way depending on the offshore wave height, winds, and tidal stage.

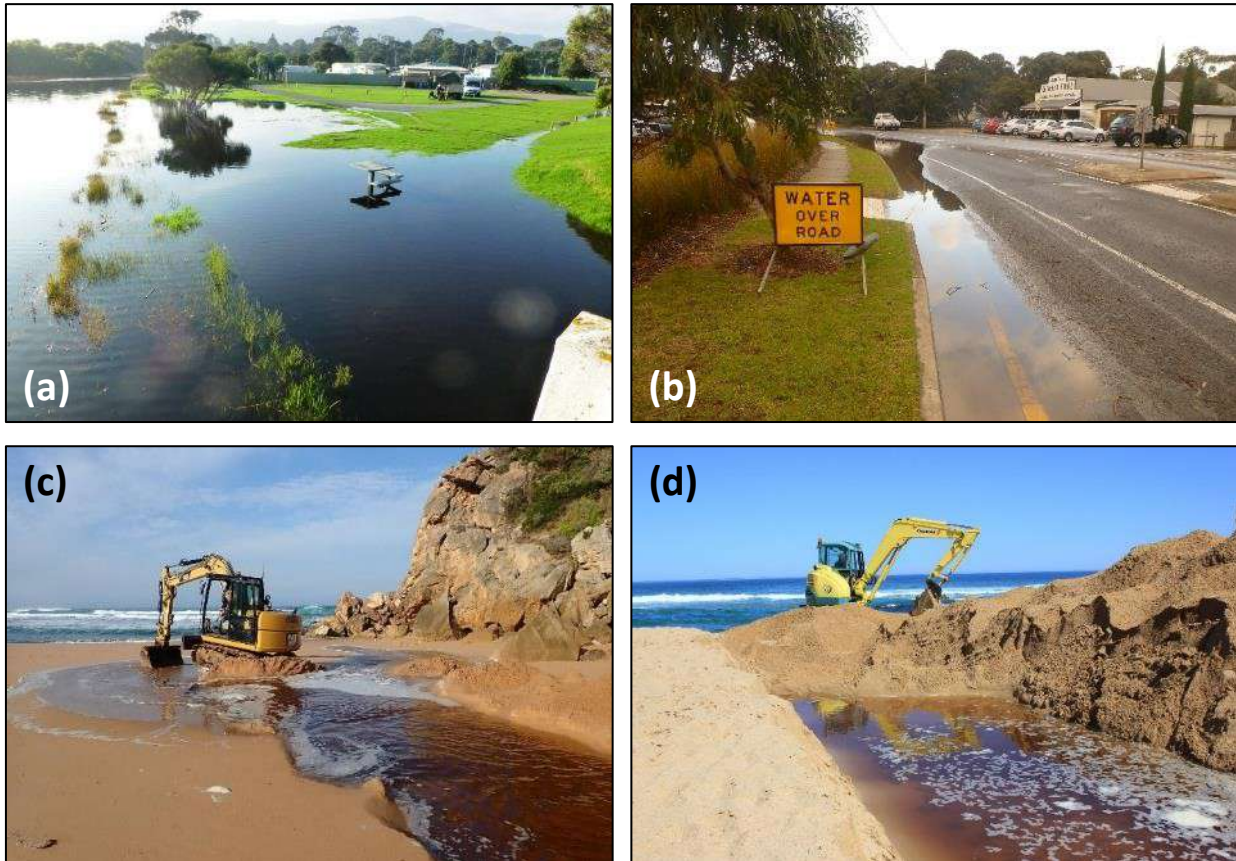
**Figure 1a-d.** (a) Flooding at the Barham and (b) Anglesea River estuaries prior to artificial opening; (c-d) artificial openings being undertaken at the Gellibrand River estuary. Photos from EstuaryWatch (2019).

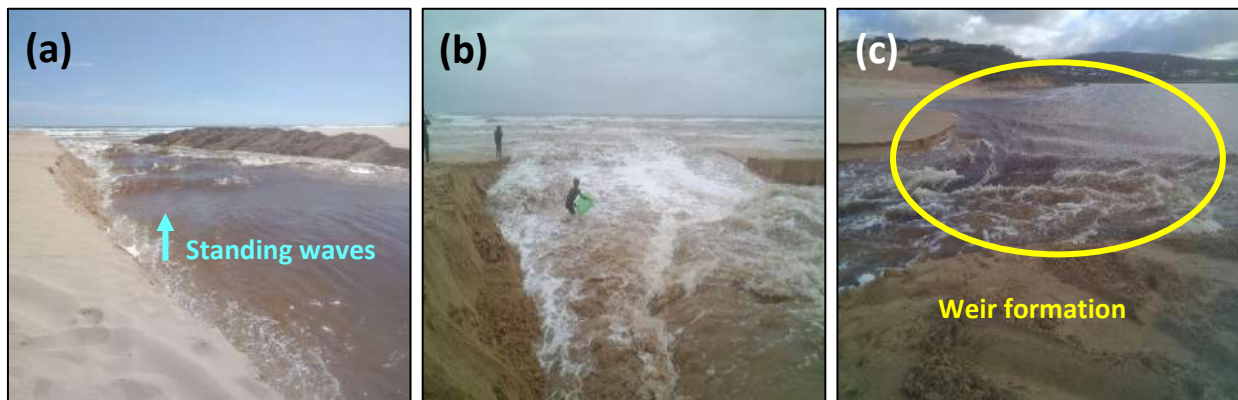
**Figure 7a-c.** Rapid expansion stage: (a) Aire River; (b) Spring Creek; (c) Painkalac Creek - with weir present and scouring of the upstream crest of the berm.

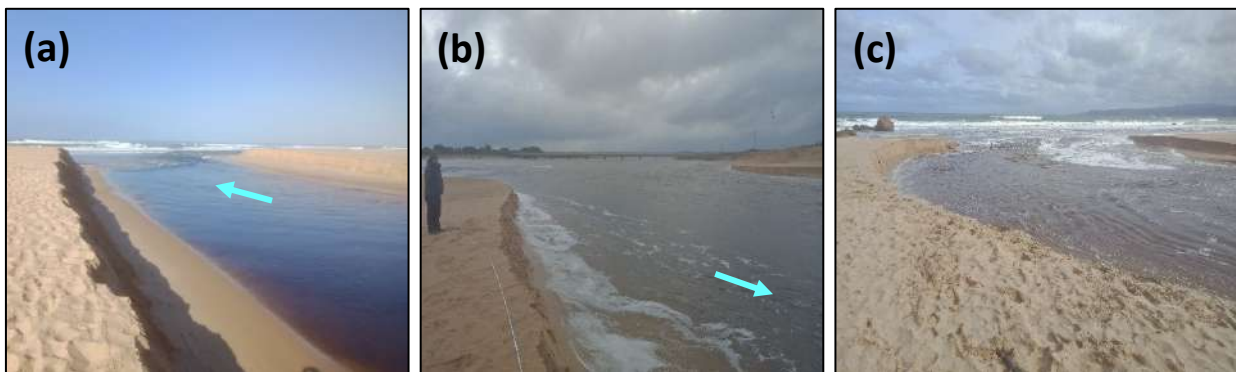
**Figure 8a-c.** River flow stage: (a) Aire River; (b) Curdies Inlet; and (c) Painkalac Creek with wave intrusion.

Stage 3 consists of the falling limb of the discharge hydrograph (Figure 8) and the estuary enters a lower energy state. Here the estuary water level has decreased substantially to reduce hydraulic head. This causes the outflow velocity, discharge, and in-channel erosion rates to progressively decrease. Velocity falls below 1.5 m/s and the channel stops incising and widening. Standing waves disappear and flow becomes subcritical. Stage 3 will persist until the estuary stops draining. Late in Stage 3, waves may move into the mouth at high tide coinciding with low outflow velocities. Waves may travel into the lower basin resulting in an influx of salt water. The duration of Stage 3 is between 4-30 hrs or more and depends on

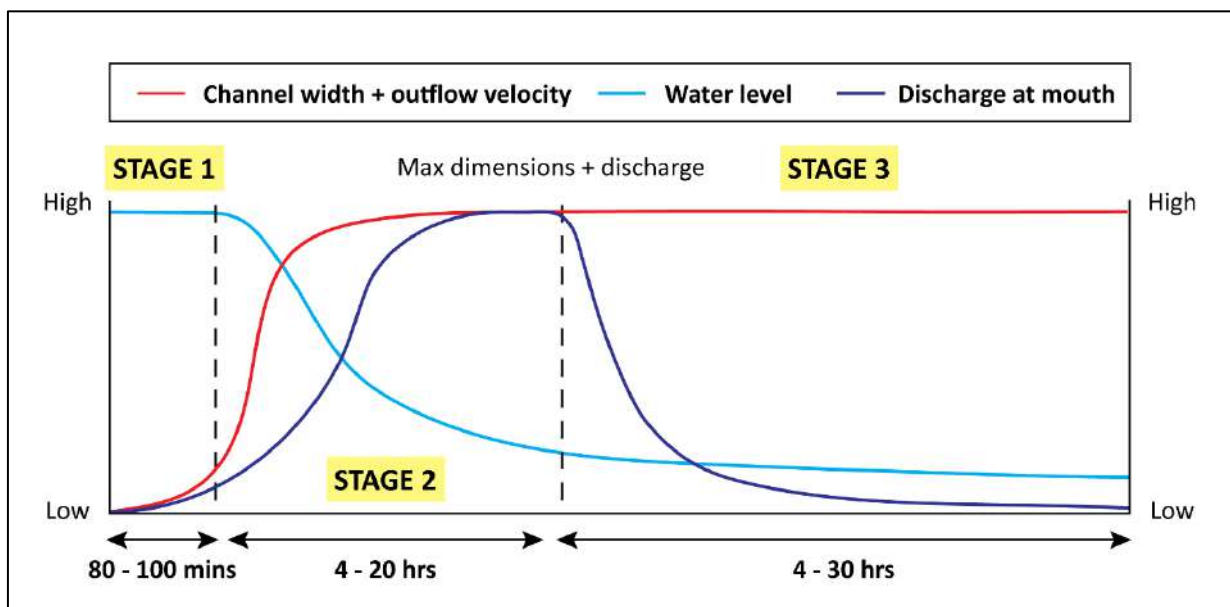
**Figure 9.** Conceptual diagram showing the three stages within the sequence of entrance opening and the relative timing of changes in the estuary channel dimensions, basin water level, and discharge/outflow.

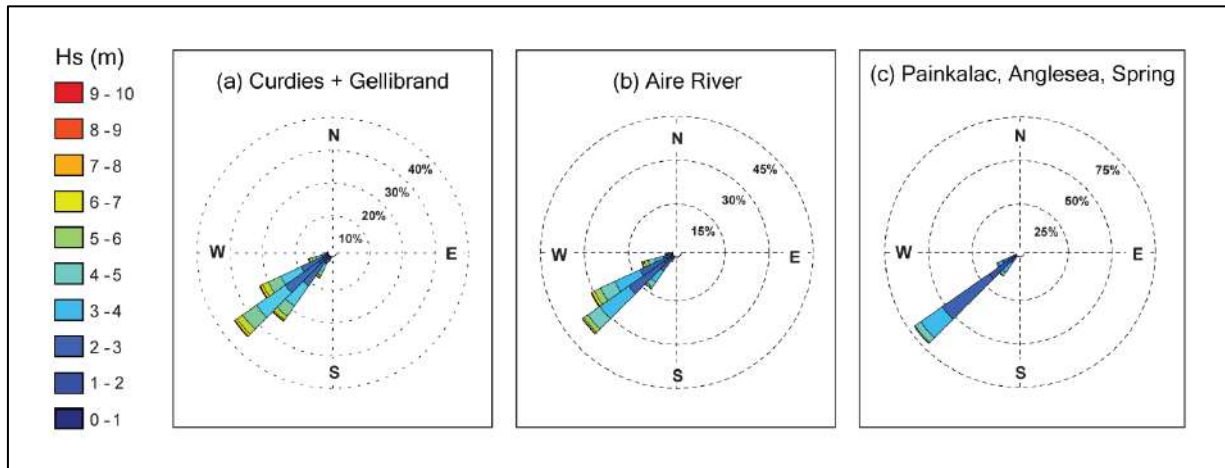
**Figure 11a-c.** Open ocean wave direction roses (Hs is significant wave height) (NOAA WaveWatch III data).

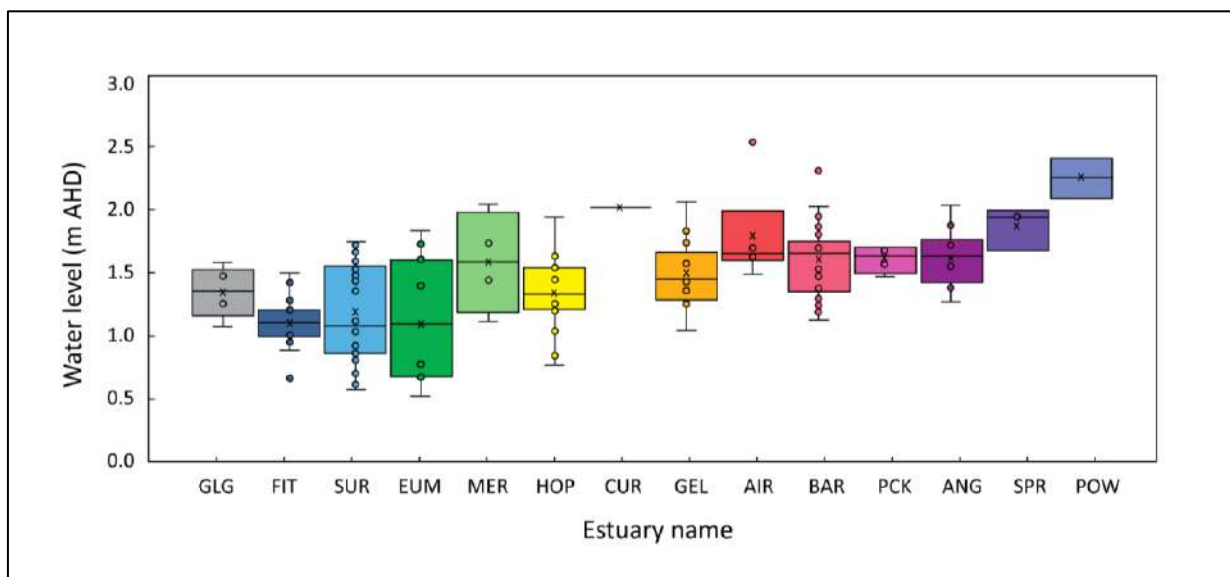
**Figure 14.** Distributions of water levels at which estuaries naturally open. GLG (Glenelg); FIT (Fitzroy); SUR (Surrey); EUM (Eumeralla); MER (Merri at Rutledges Cutting); HOP (Hopkins); CUR (Curdies); GEL (Gellibrand); AIR (Aire); BAR (Barham); PCK (Painkalac); ANG (Anglesea); SPR (Spring); and POW (Powlett).

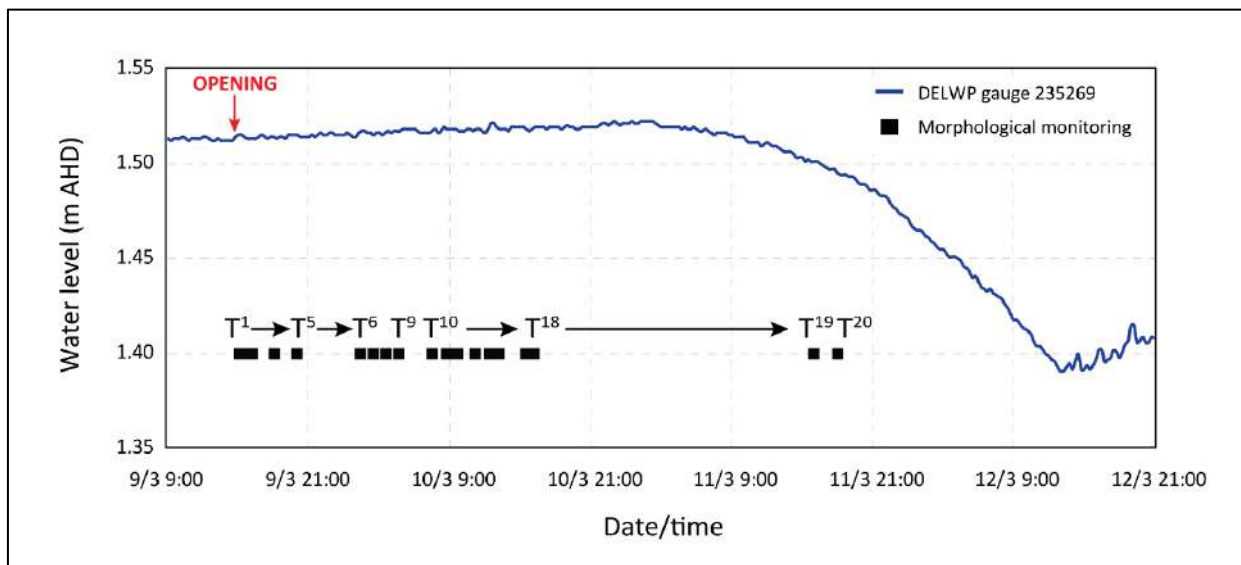
**Figure 18.** Basin water level drainage curve from DELWP gauge at Princetown (235269) (logging every 15 min) and the timing of morphological monitoring at Gellibrand River estuary mouth 09/03/19 - 12/03/19.

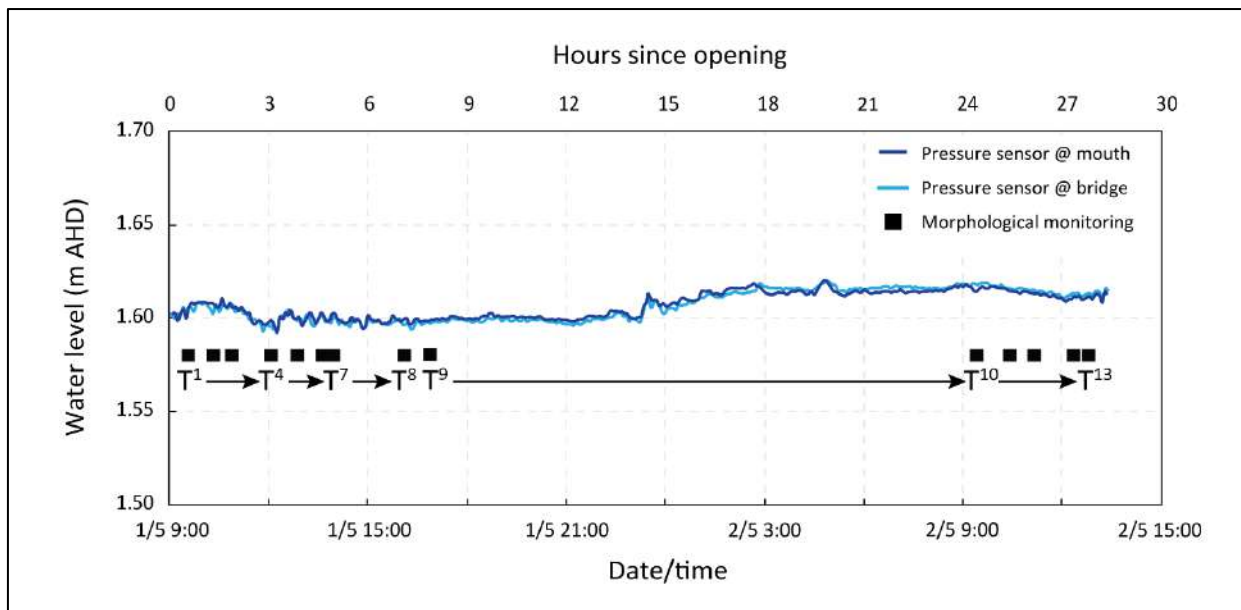
**Figure 21.** Basin water level (every 5 min) and the timing of morphological monitoring at the Aire River.

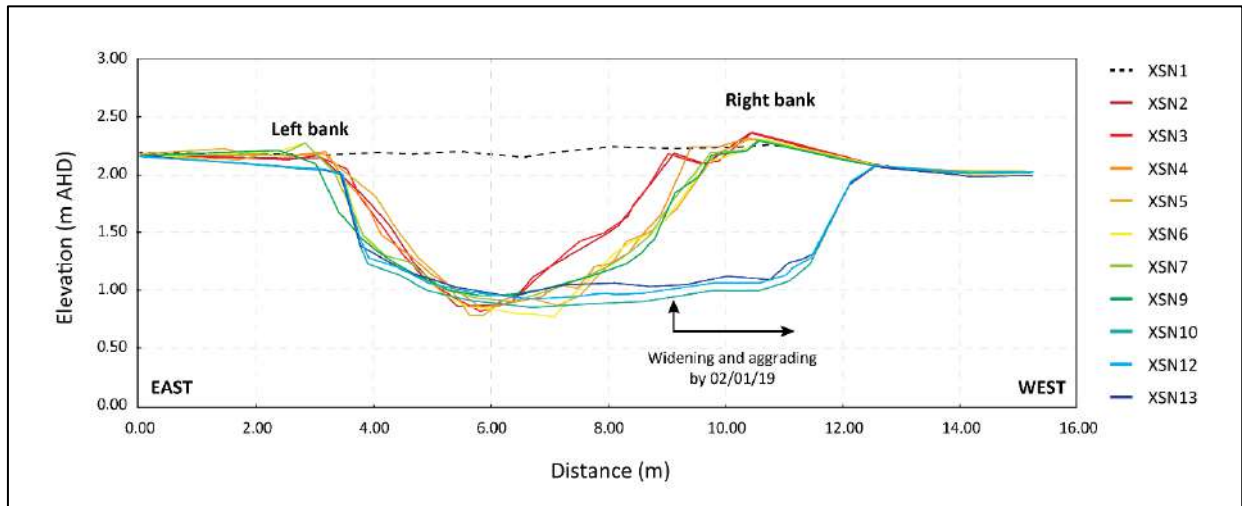
**Figure 22.** Surveyed entrance morphology at the mouth of Aire River 01/05 - 02/05 (XSN = cross-section).

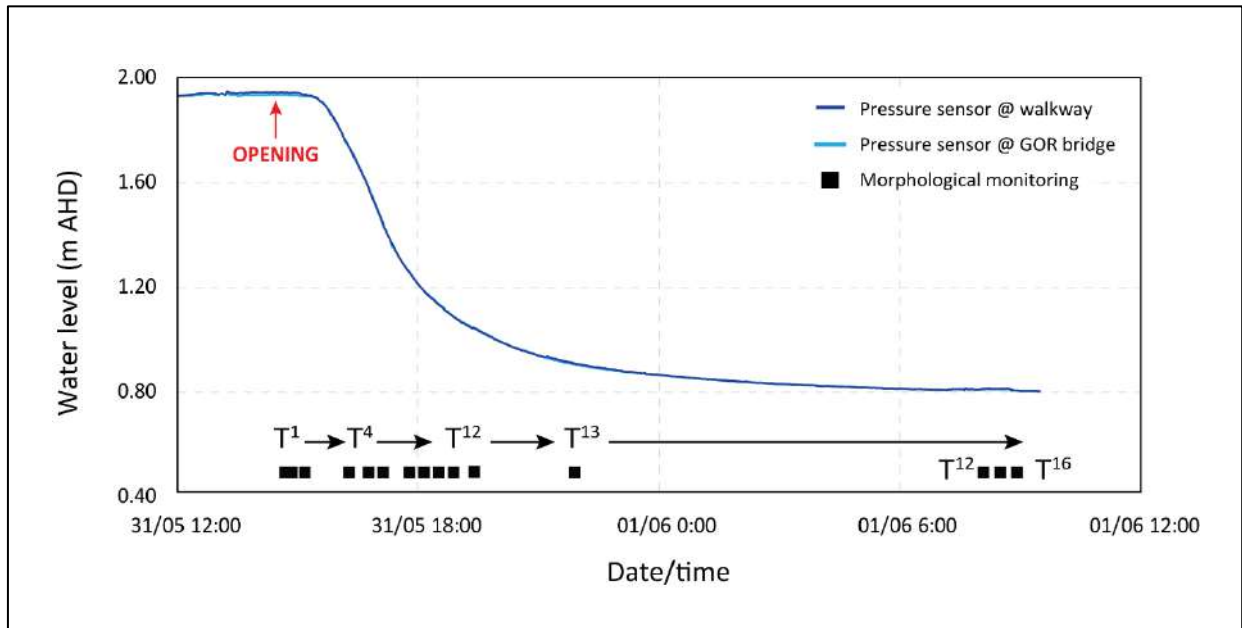
**Figure 25.** Spring Creek drainage curve from pressure sensors and timing of morphological monitoring.

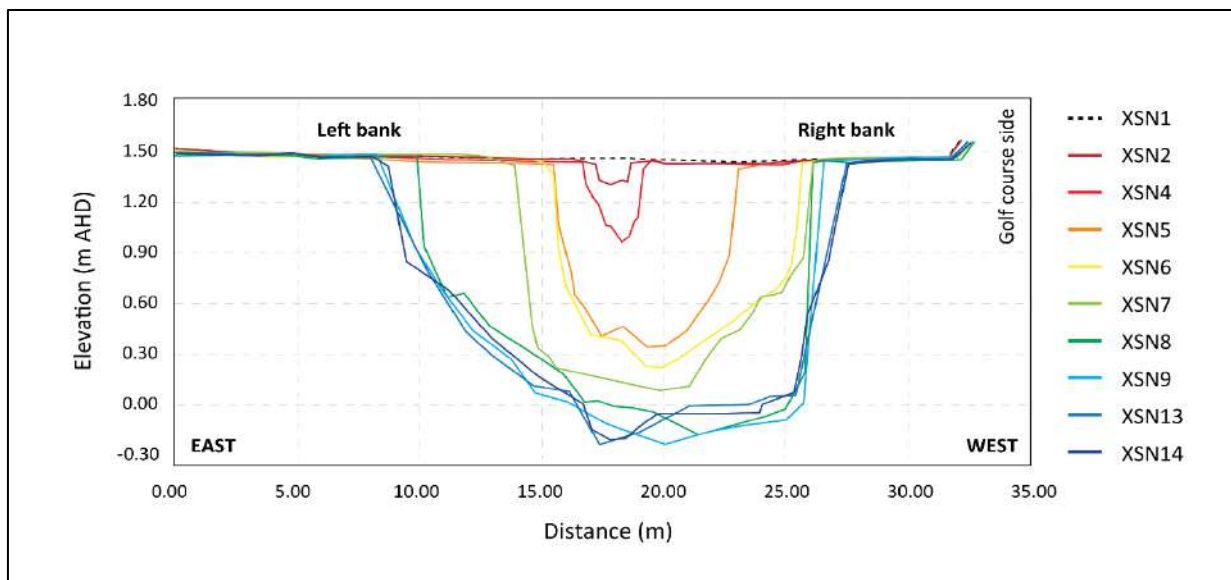
**Figure 26.** Select surveyed entrance channel cross-sections at the mouth of Spring Creek estuary during 31/05 - 01/06/19.

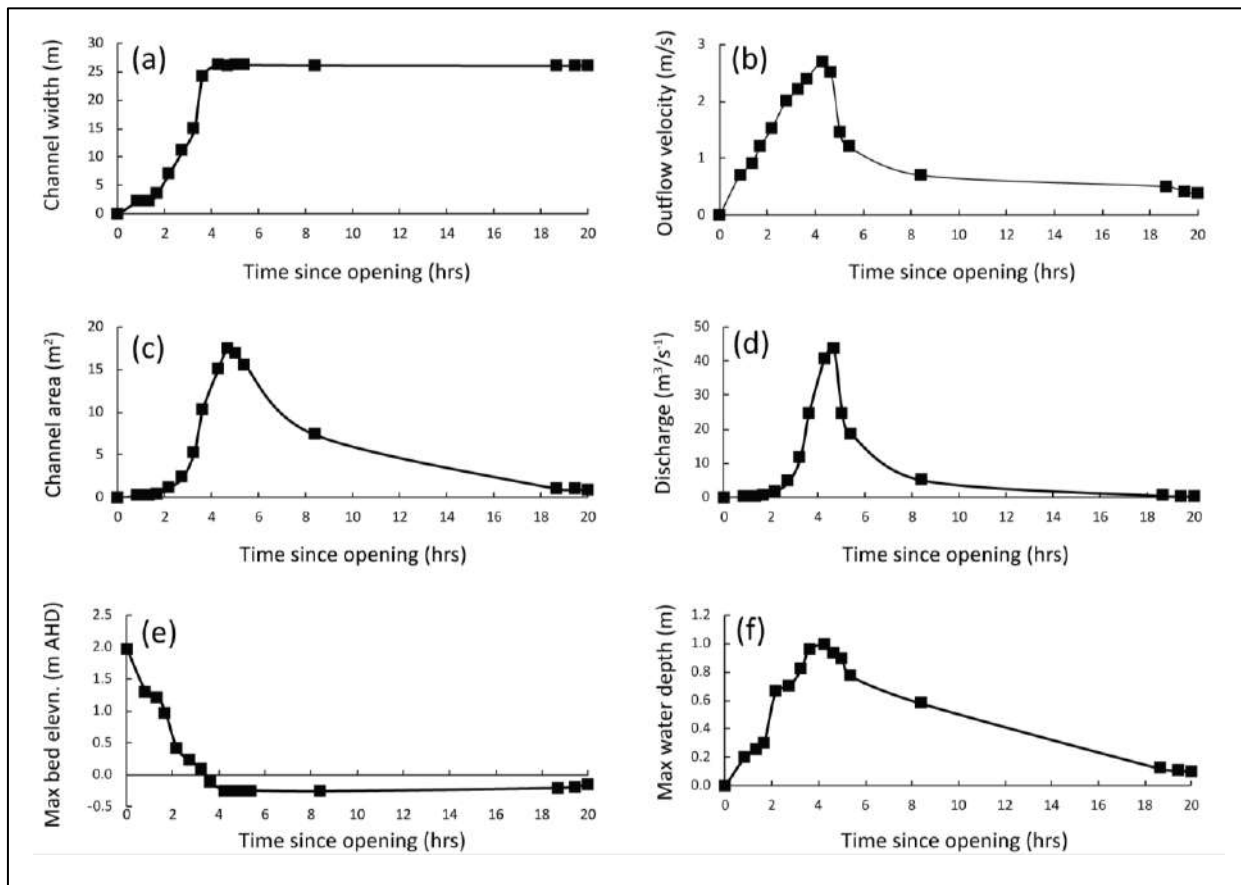
**Figure 27a-f.** Change in (a) channel width; (b) outflow velocity; (c) cross-sectional area; (d) discharge; (e) max bed elevation; (f) max water depth during Spring Creek artificial opening 31/05/2019 - 01/06/2019.

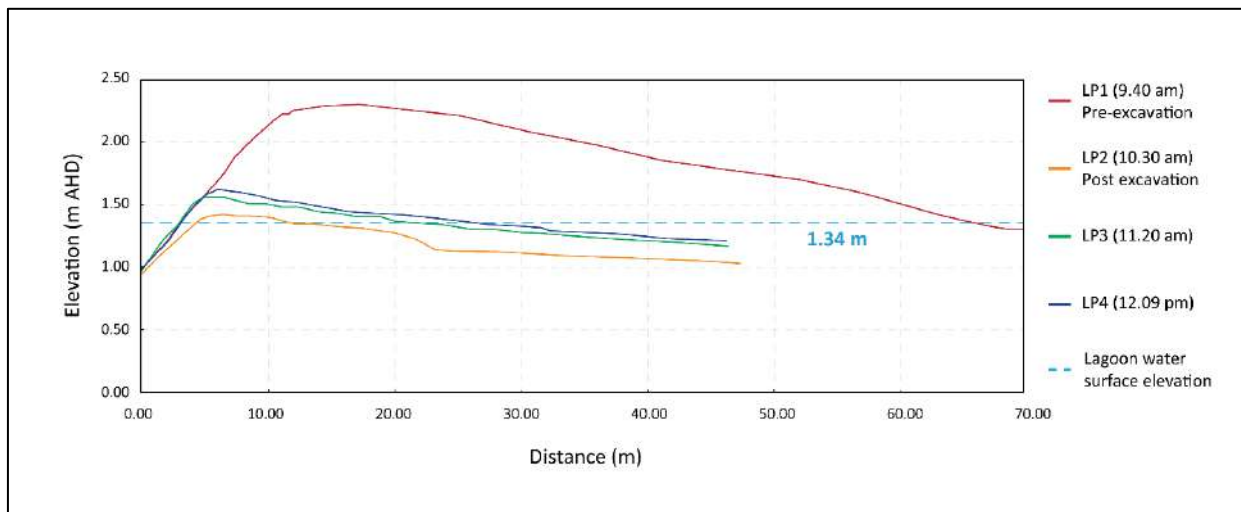
**Figure 29.** Surveyed long profiles from swash to seaward edge of the lagoon at Curdies Inlet on 16/06/19.

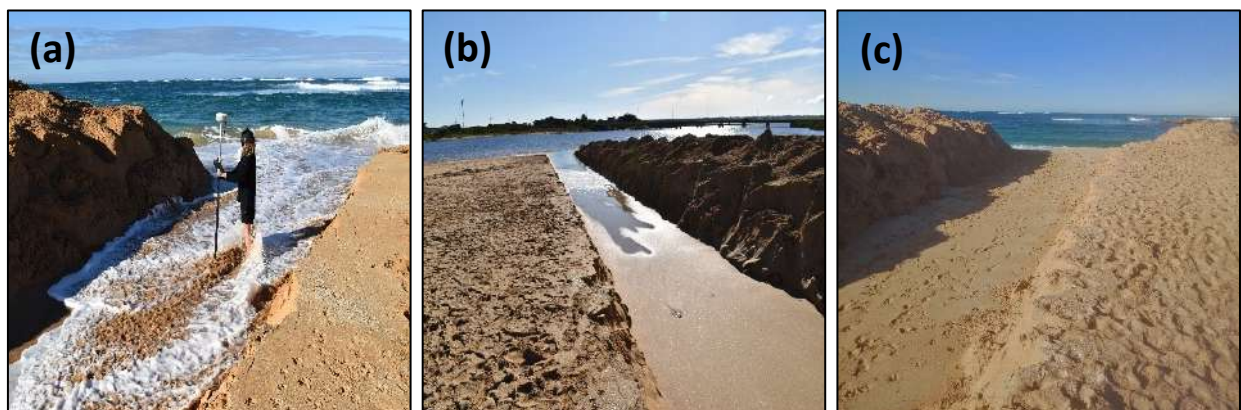
**Figure 30a-c.** (a) Curdies Inlet channel infill via waves 11.20 am 16/06/19; (b) looking towards the lagoon showing infill of the channel and a cessation of outflow 1 pm 16/06; (c) looking seaward at 2 pm 16/06.

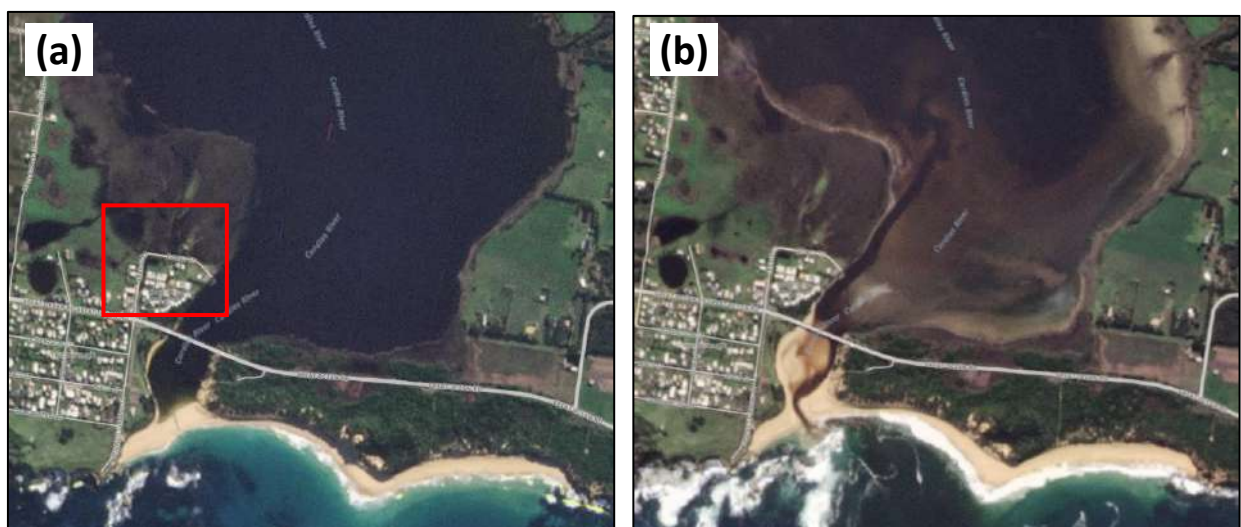
**Figure 31a-b.** (a) Curdies Inlet 17/06/19 showing inundation of Dorey St (red square); (b) 23/06/19 after second opening showing drainage of floodwaters. Images from Planet Team (2019).

decrease at all during the opening, persistent flooding on Dorey Street resulted in road closure and emergency conditions which prompted a second opening the next day on 17/06 (Figure 31; Figure 32).

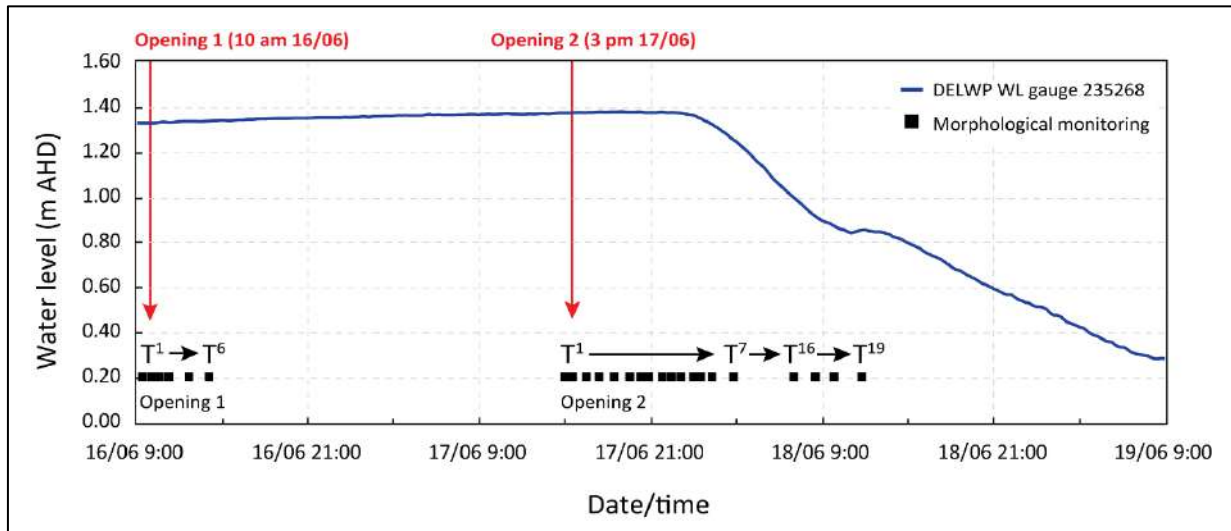
**Figure 32.** Curdies Inlet drainage curve from pressure sensors and timing of morphological monitoring.

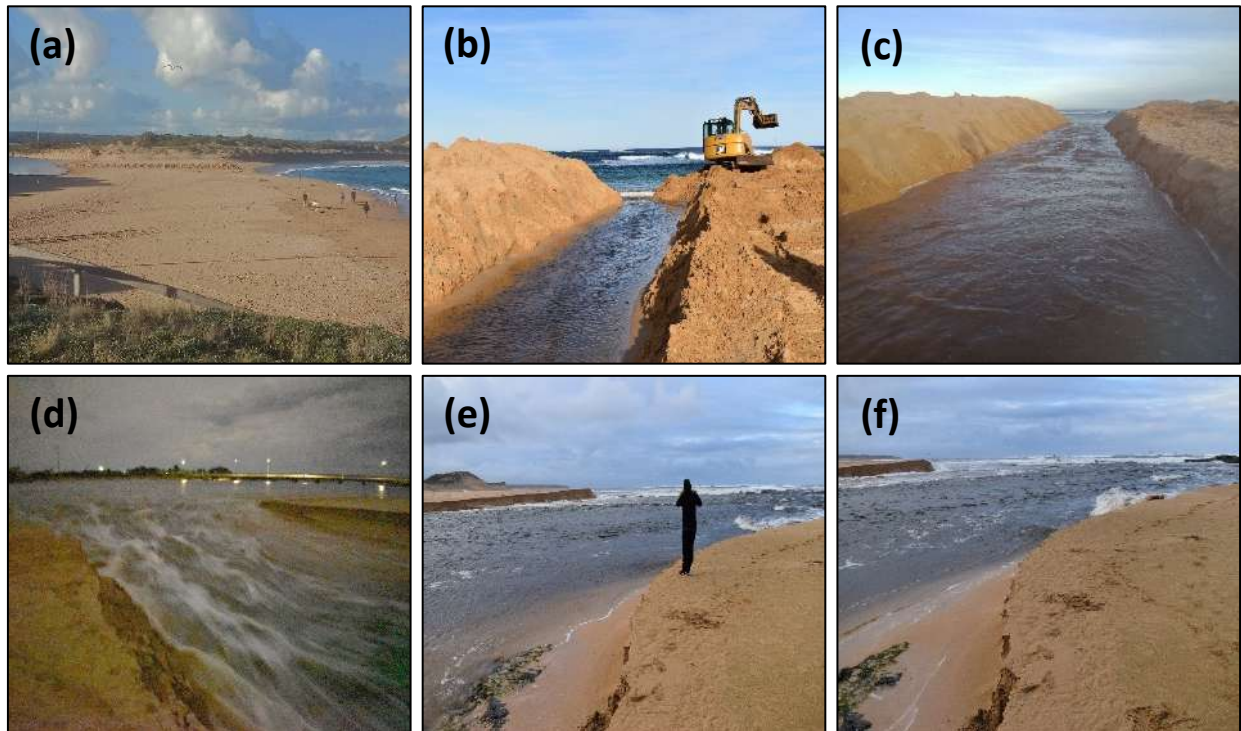
**Figure 34a-f.** Pictures from artificial opening 2 at Curdies Inlet. (a) 9 am 17/06/19 prior to opening; (b) 3 pm 17/06 excavation; (c) 5 pm 17/06 channel expansion; (d) 2.50 am 18/06 near peak outflow with standing waves (picture brightened); (e) 8 am 18/08 peak discharge; (f) 11 am 18/06 wave intrusion.

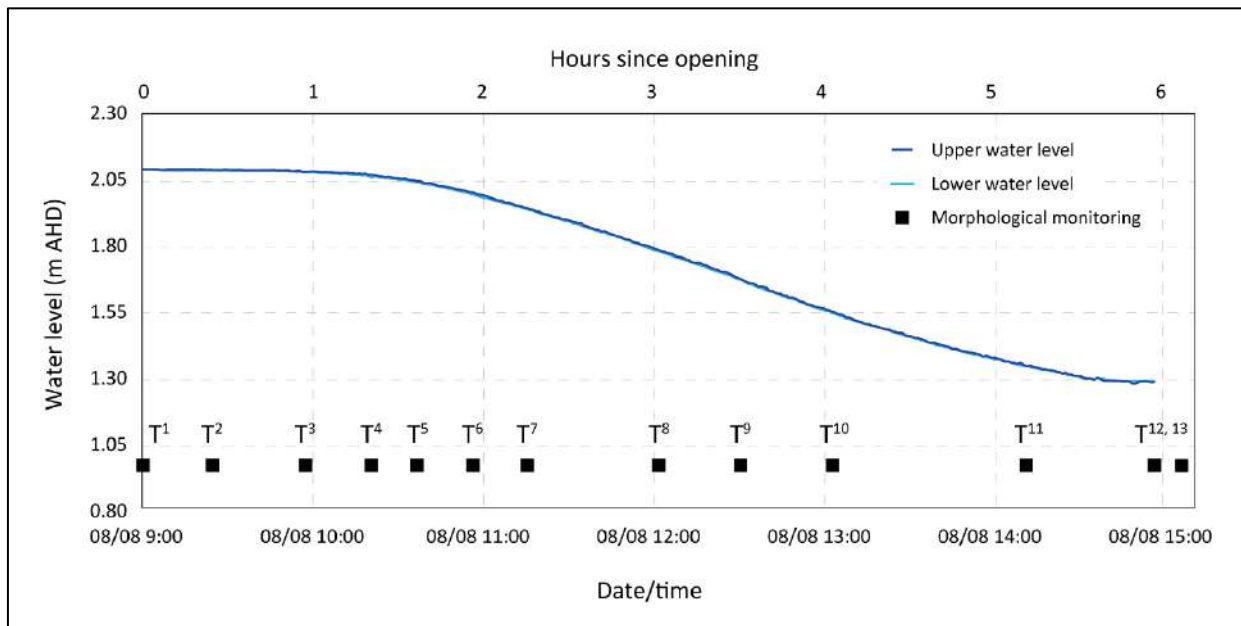
**Figure 35.** Painkalac Creek drainage curve from pressure sensors and timing of morphological monitoring.

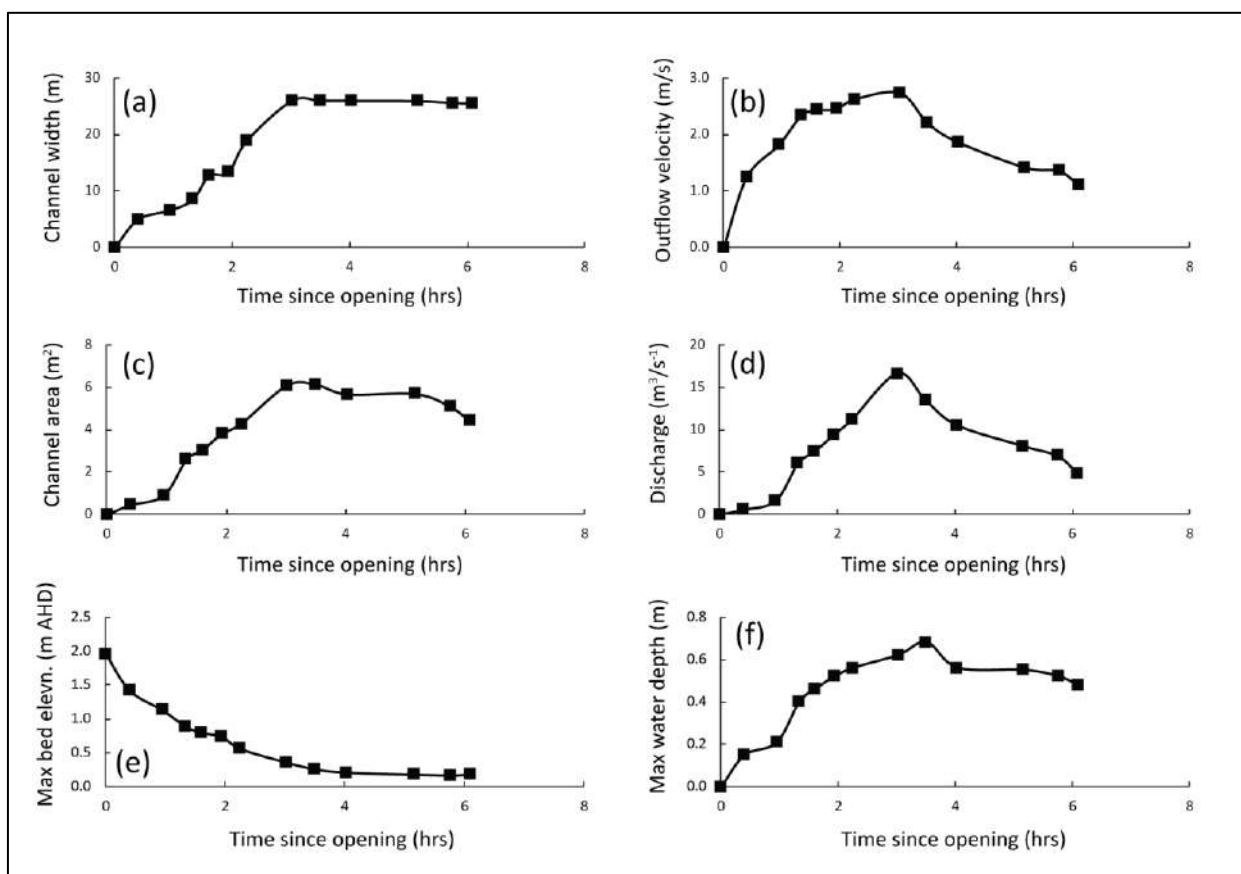
**Figure 36a-f.** Change in (a) channel width; (b) outflow velocity; (c) cross-sectional area; (d) discharge; (e) max bed elevation; (f) max water depth during Painkalac Creek artificial opening 08/08/2019.

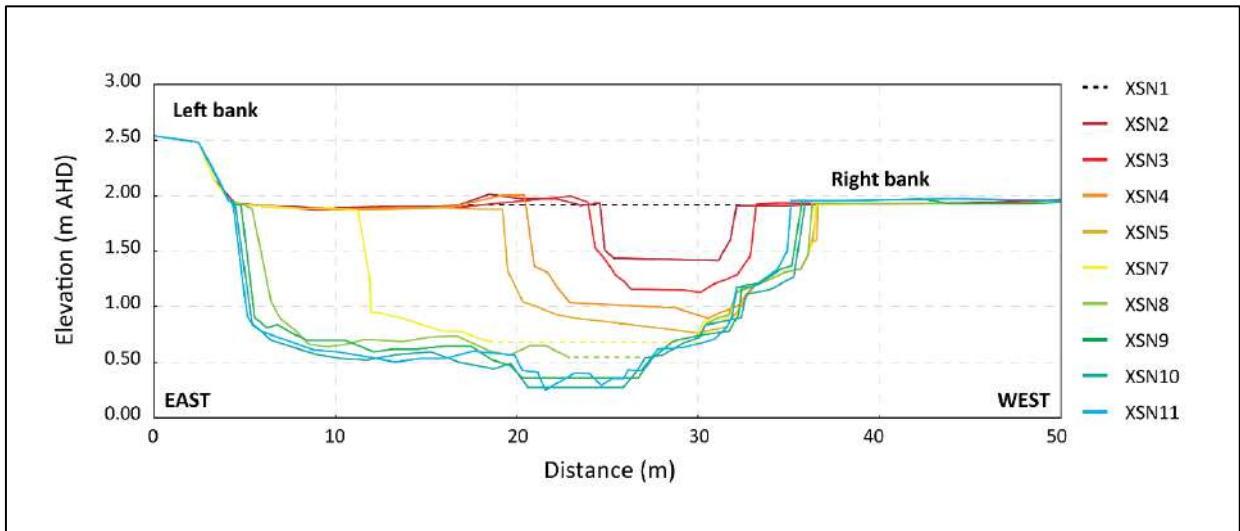
**Figure 37.** Select surveyed entrance channel cross-sections at the mouth at Painkalac Creek on 08/08/19.

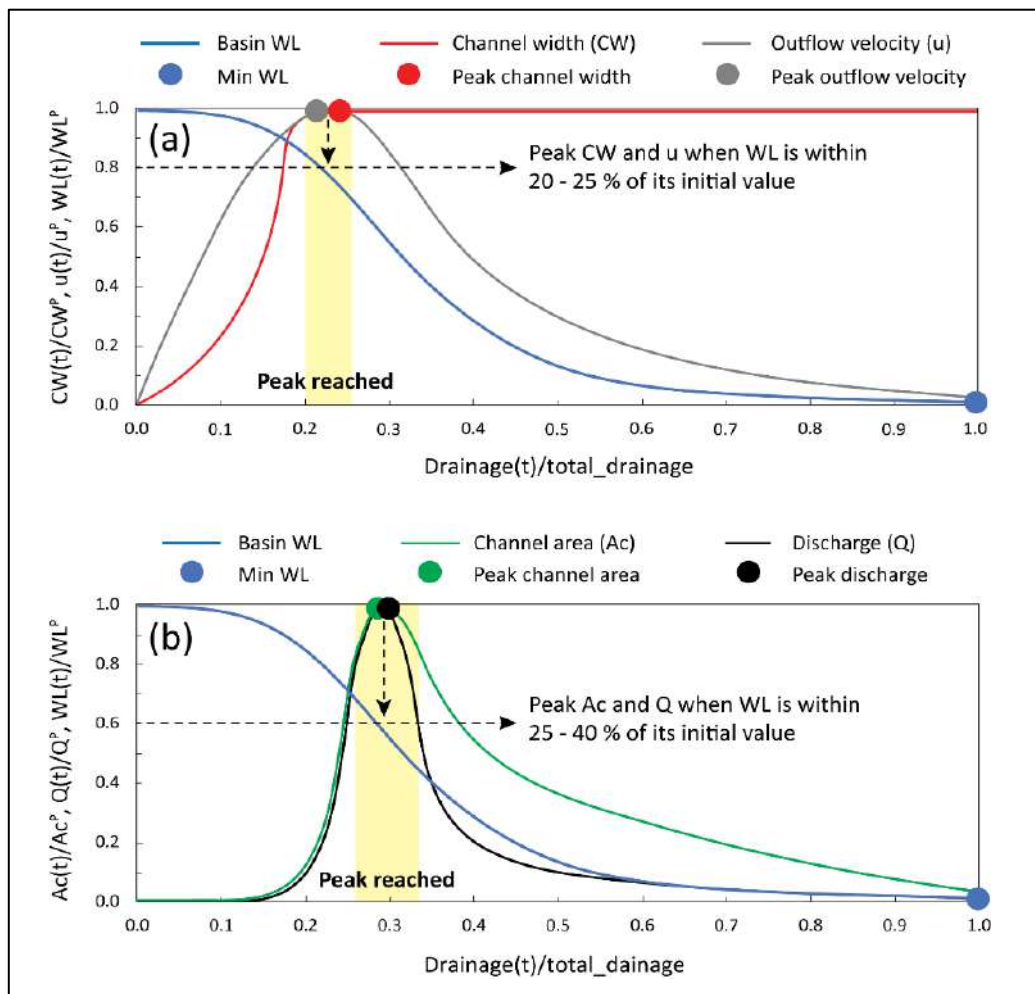
**Figure 43a-b.** Conceptual diagram showing (a) change in channel width and velocity vs water level, and (b) change in cross-sectional area and discharge vs water level.  $x(t) = x$  at that time;  $x^p$  is the peak value.

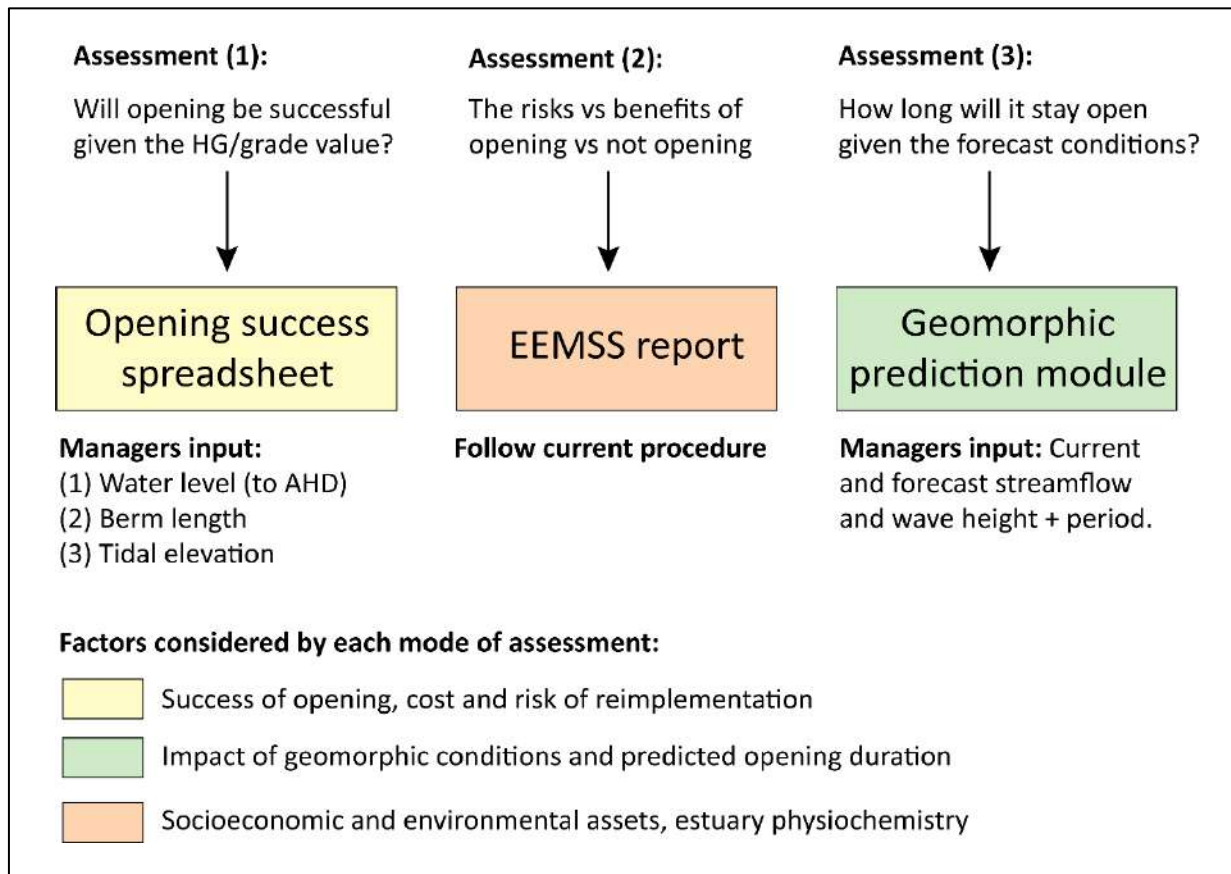
**Figure 52.** A potential method to incorporate (1) the pre-opening HG calculation to determine if an opening is likely to be successful and (3) the Geomorphic Prediction Module (part I of this project) alongside EEMSS in estuary entrance management decision making.
