PAINKALAC CREEK ESTUARY 2016

An interpreted summary of data

Date range:
01/01/2016 – 31/12/2016

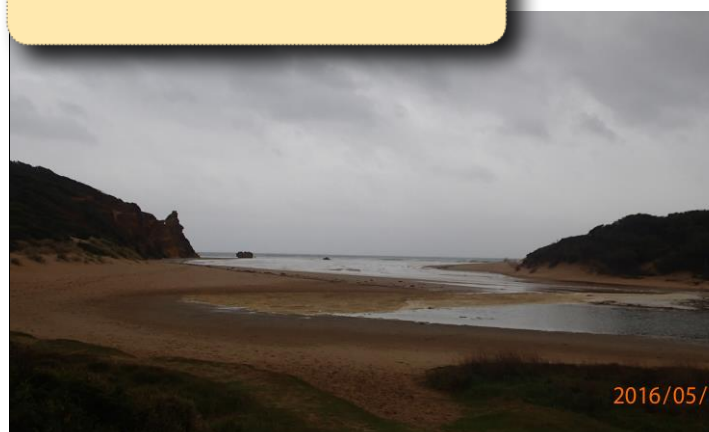
The breaching of the beach berm enabling sea water to enter the Painkalac Creek estuary on May 11 2016.

The Painkalac Creek estuary is an intermittently open estuary. In 2016 there was one permitted emergency artificial estuary opening recorded on July 22 (2.2m AHD) and one natural opening during August. The estuary mouth remained closed for the first half of the year, isolating the estuary from the sea. Estuary mouth closures were recorded at many other estuaries in Victoria during 2016. Over the twelve months salinity levels indicate the estuary waters to be mostly brackish, with the exception of October and November with sea water entering the estuary when the estuary mouth was open. The salinity ranged from 0.6 – 31.2 ppt. The dissolved oxygen levels ranged from 1.2 – 129 % saturation during the year, the lowest level was observed on September 9 in the very bottom waters at The Bend (site P4) at a time when the estuary was stratified. The highest level was recorded in the very bottom waters from Woods Property (site P5), the most upstream site, likely due to algal growth on the bottom substrate. The pH levels ranged from 4.9 – 9.0 pH units. **EstuaryWatch records at Painkalac Creek estuary extend from 2007 and can be viewed at www.estuarywatch.org.au.**

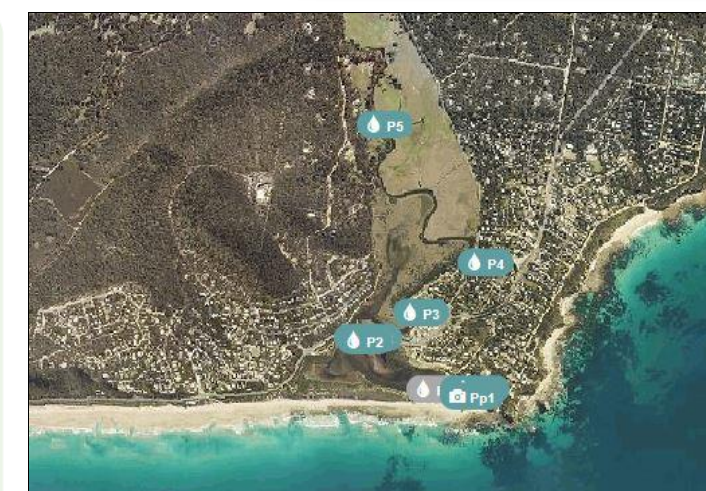
Map of the Painkalac Creek estuary and EstuaryWatch monitoring sites.
