# Assessment of Victoria's estuaries using the Index of Estuary Condition: Results 2021

DELWP (2021). Assessment of Victoria's estuaries using the Index of Estuary Condition: Results 2021. The State of Victoria, Department of Environment, Land, Water and Planning, East Melbourne, Victoria.

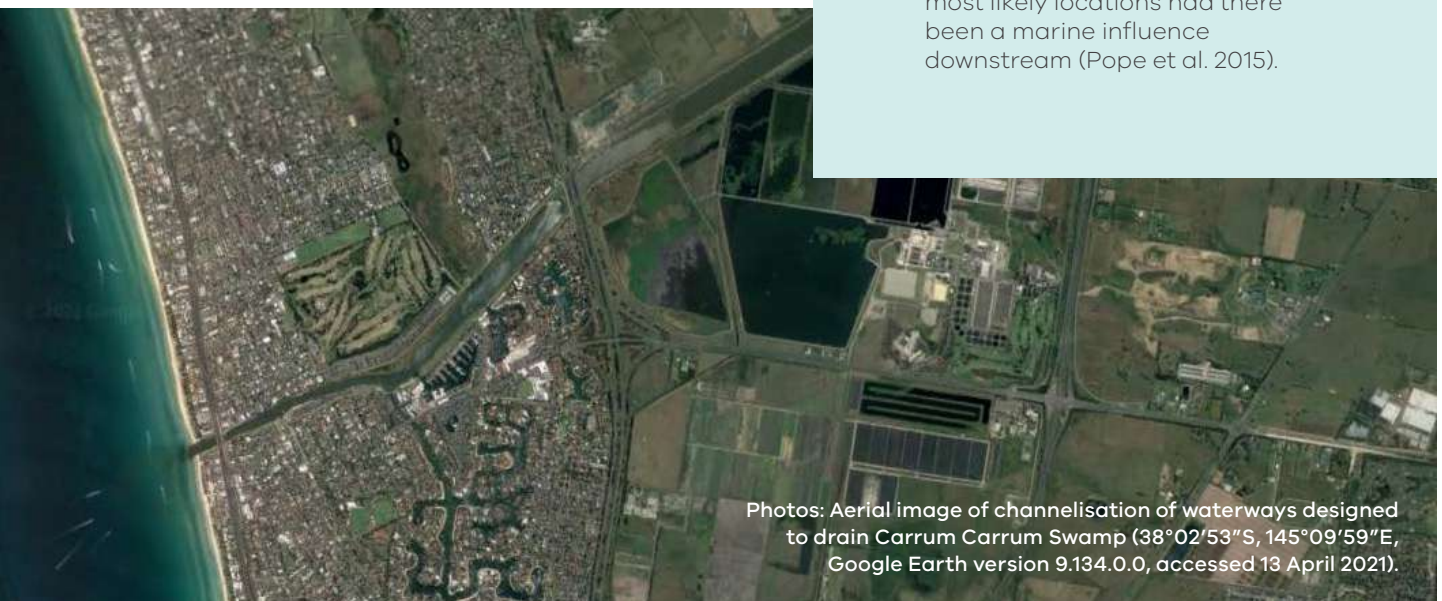
Photos: Aerial image of channelisation of waterways designed to drain Carrum Carrum Swamp (38°02'53"S, 145°09'59"E, Google Earth version 9.134.0.0, accessed 13 April 2021).

Two large swamps once existed in the Melbourne region; the Carrum Carrum swamp and the Koo Wee Rup Swamp. Multiple waterways drained to these swamps, but there may have only been one or two outlets from the swamp connecting to Port Phillip Bay or Western Port. In the mid to late 1800s, multiple new watercourses (cut drains) were created to convert low-lying swamp to land suitable for agriculture and urban growth. These new channels terminated in some estuaries that would have not previously existed. Some of these 'new' estuaries have been assessed in the IEC. The Physical Form score of many of these 'new' estuaries was assessed as moderate: whilst they often had large extents of their shorelines covered by built structures, they often had minimal barriers (consistent with their primary purpose being drainage). For such watercourses, there was no 'natural' inland extent of the estuary. Therefore, when calculating the Artificial Barriers measure, the endpoints of the 'natural' inland extents for these estuaries were estimated from the most likely locations had there been a marine influence downstream (Pope et al. 2015).
